TECHNICAL REPORT GL-87-14

# SEISMIC STABILITY EVALUATION OF FOLSOM DAM AND RESERVOIR PROJECT

Report 2  
INTERFACE ZONES

David W. Sykora, Mary Ellen Hynes

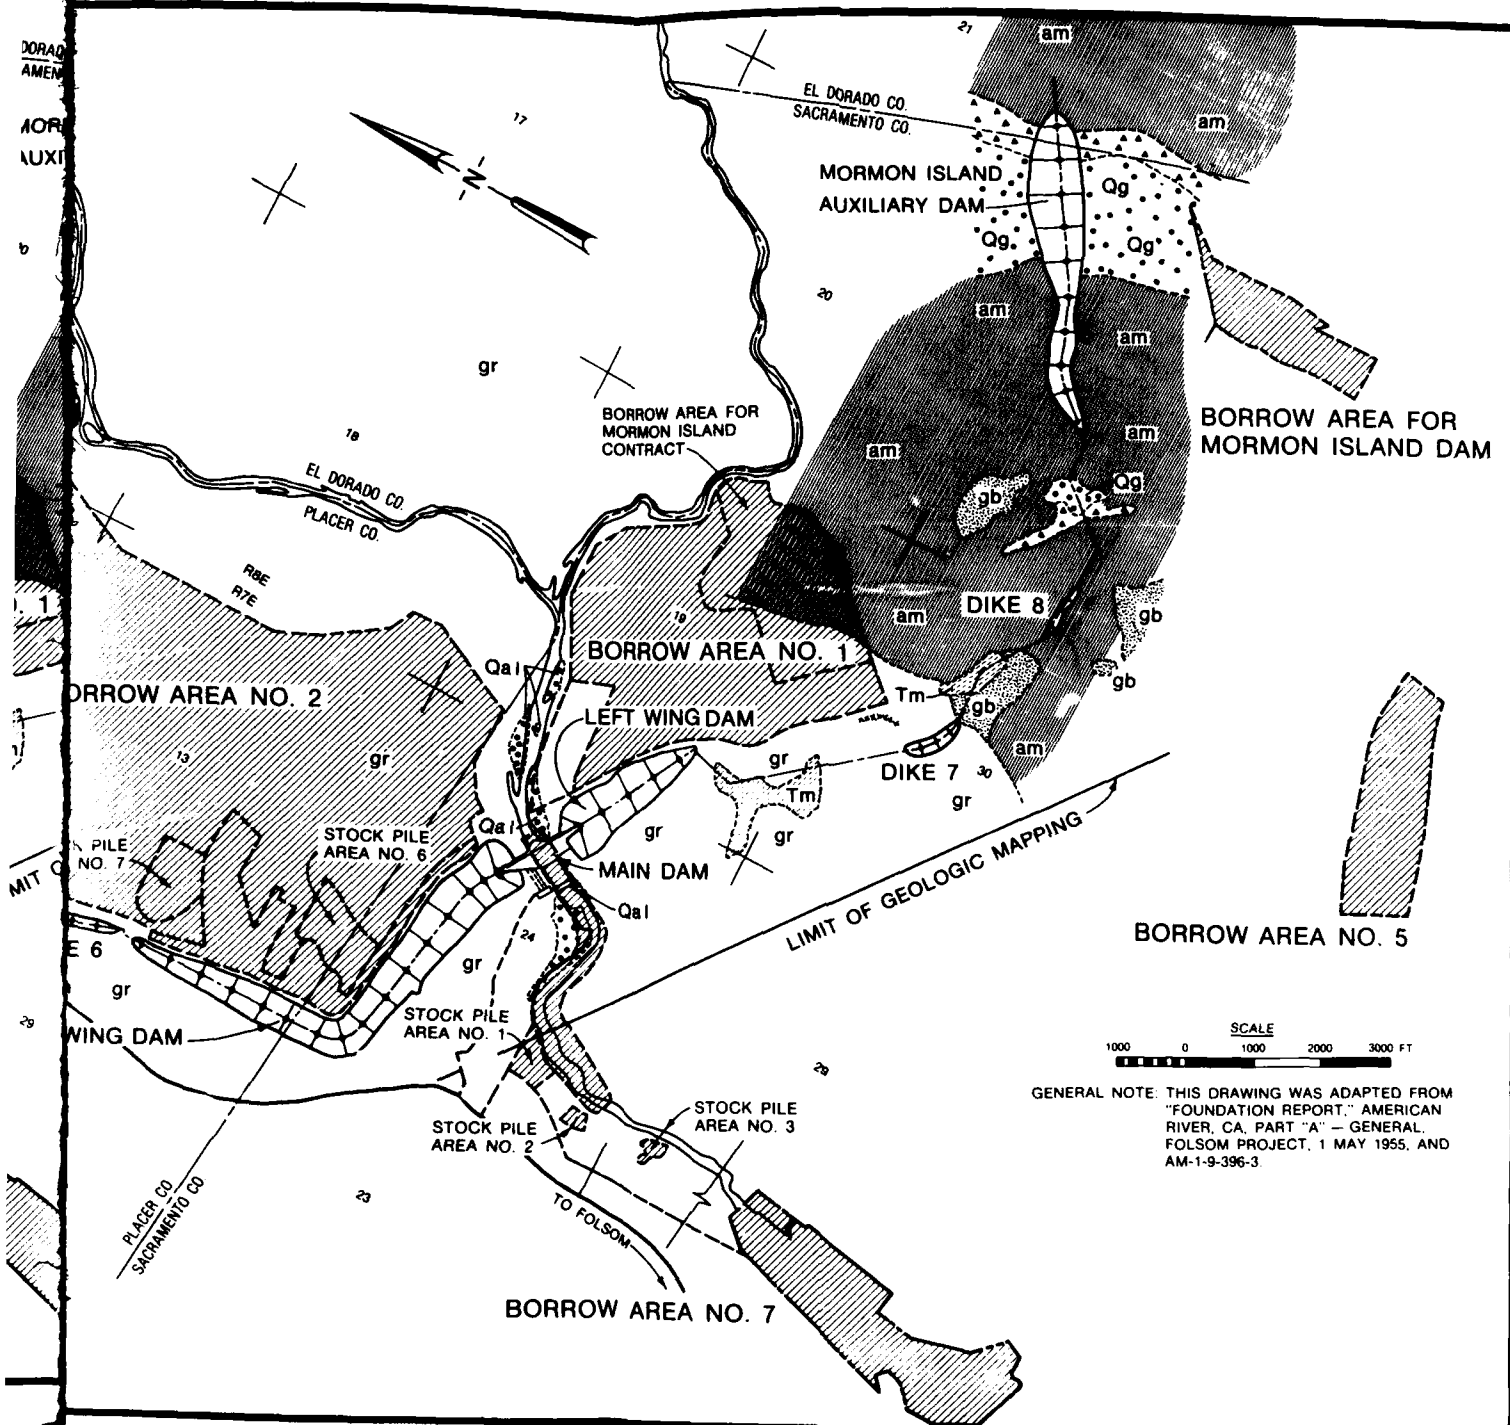
Layout of Folsom Dam and Reservoir amid surface geology and locations of borrow sources

17. The important formations at the dam site are: a quartz diorite granite which underlies the CGD, RWD, and LWD and Saddle Dikes 1 through 7; metamorphic rocks of the Amador group which underlie Saddle Dike 8 and the foundation at Mormon Island Auxiliary Dam; the Mehrten formation, a deposit of cobbles and gravels in a somewhat cemented clay matrix which caps the low hills that separate the saddle dikes and is part of the foundation at Dike 5; and the alluvium that fills the Blue Ravine at Mormon Island Auxiliary Dam. Bedrock geology is indicated on the plan in Figures 2 and 4.

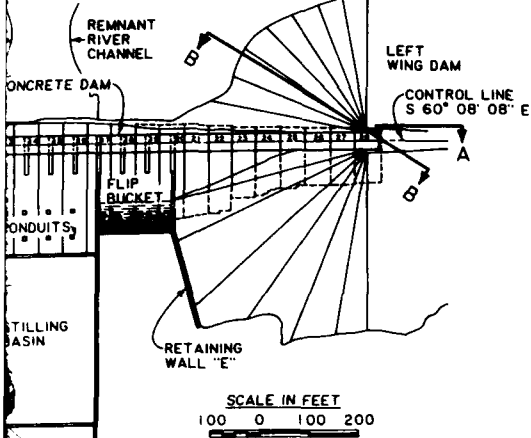
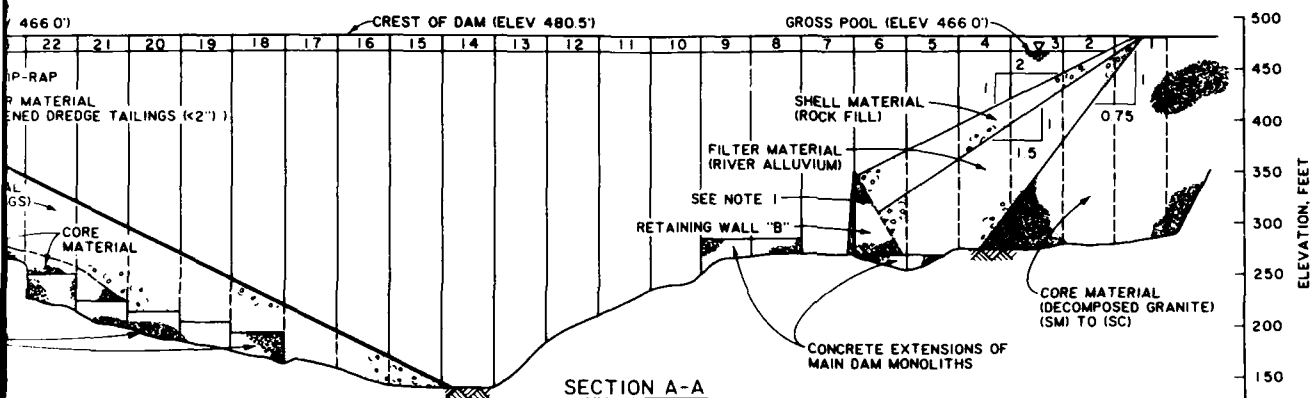
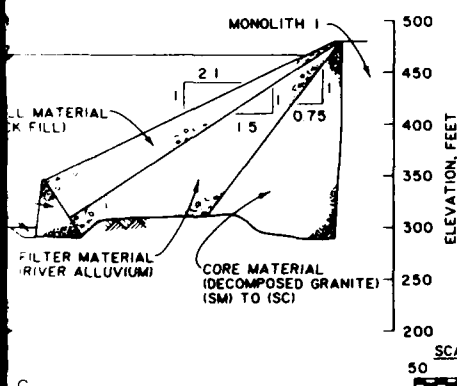
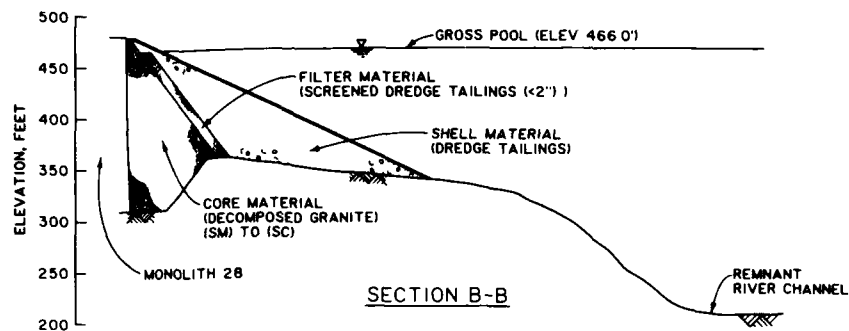
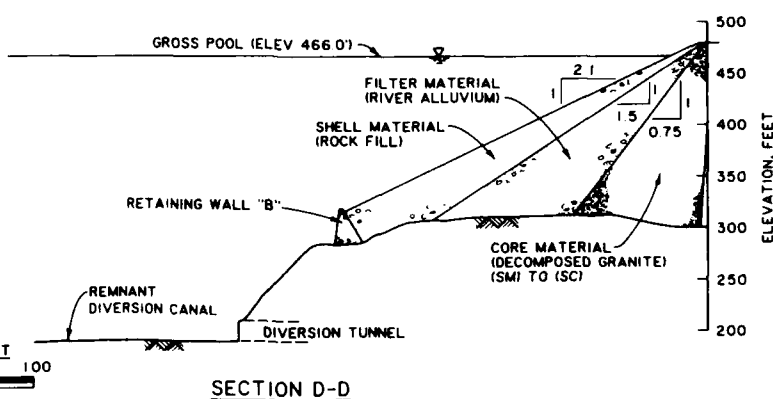
PLAN VIEW

SECTION C-C

Plan and sections of upstream envelopment areas and Retaining Wall B

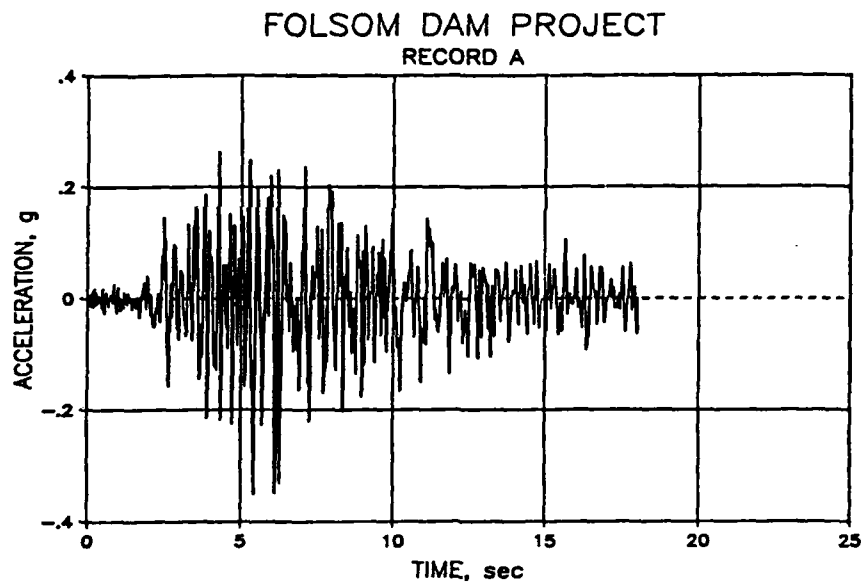
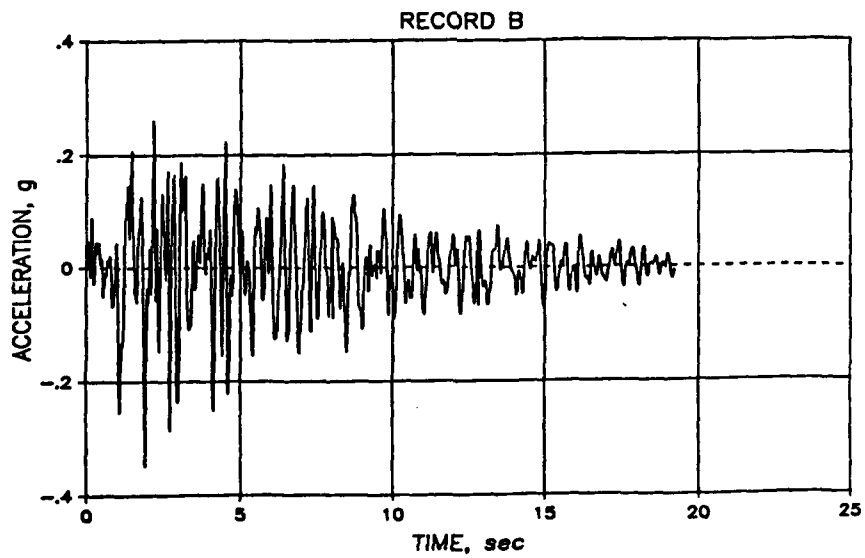
Figure 5. Acceleration time histories used in the analysis

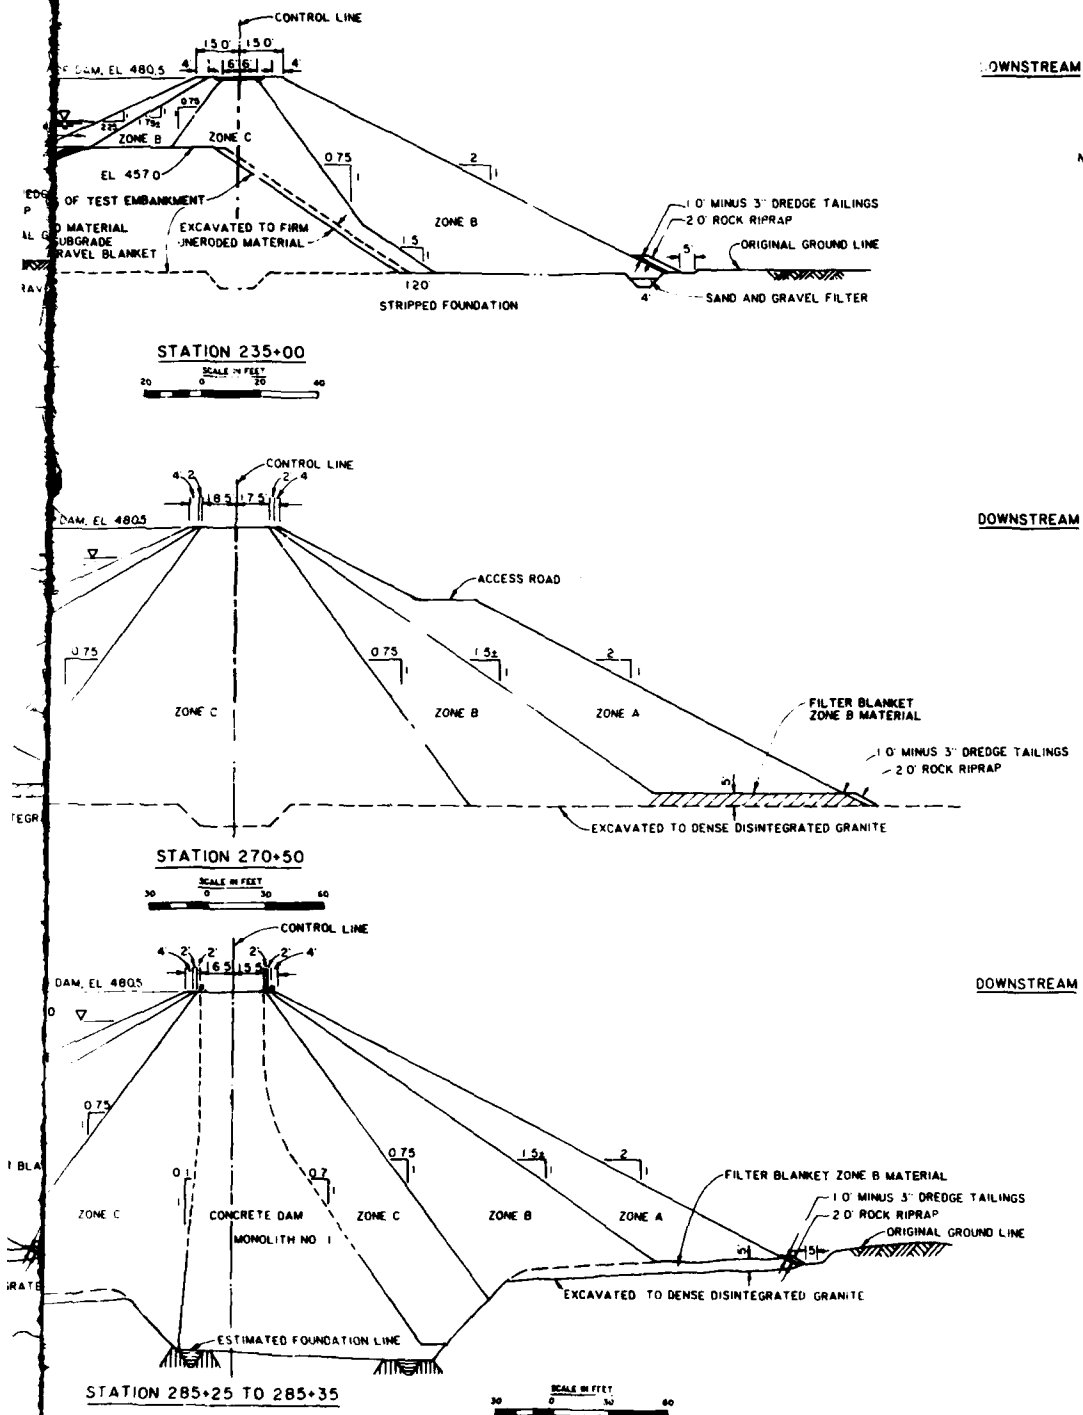
Figure 9. Typical cross-sections of LWD

- (2) ZONE A MATERIAL IS ROCK FROM THE AMERICAN RIVER CHANNEL EXCAVATION AND GOVERNMENT OWNED STOCKPILE
- (3) ZONE B MATERIAL IS UNPROCESSED SAND, GRAVEL AND COBBLES FROM AMERICAN RIVER CHANNEL EXCAVATION
- (4) LINES SHOWN ON EMBANKMENT SECTIONS SEPARATING ZONES A AND B WILL VARY IN SLOPE AS DETERMINED BY THE QUANTITIES OF MATERIALS AVAILABLE FROM AMERICAN RIVER CHANNEL EXCAVATION
- (5) WHEN MATERIAL FOR ZONE B FROM THE AMERICAN RIVER CHANNEL EXCAVATION IS EXHAUSTED, ADDITIONAL MATERIAL WILL BE OBTAINED FROM BORROW AREA NO. 7 AND APPROVED WASTE FROM PROCESSING OF CONCRETE AGGREGATE
- (6) ZONE C MATERIAL IS DECOMPOSED GRANITE FROM BORROW AREA NO. 2 AND SUITABLE FINE GRAINED MATERIAL FROM AMERICAN RIVER CHANNEL EXCAVATION

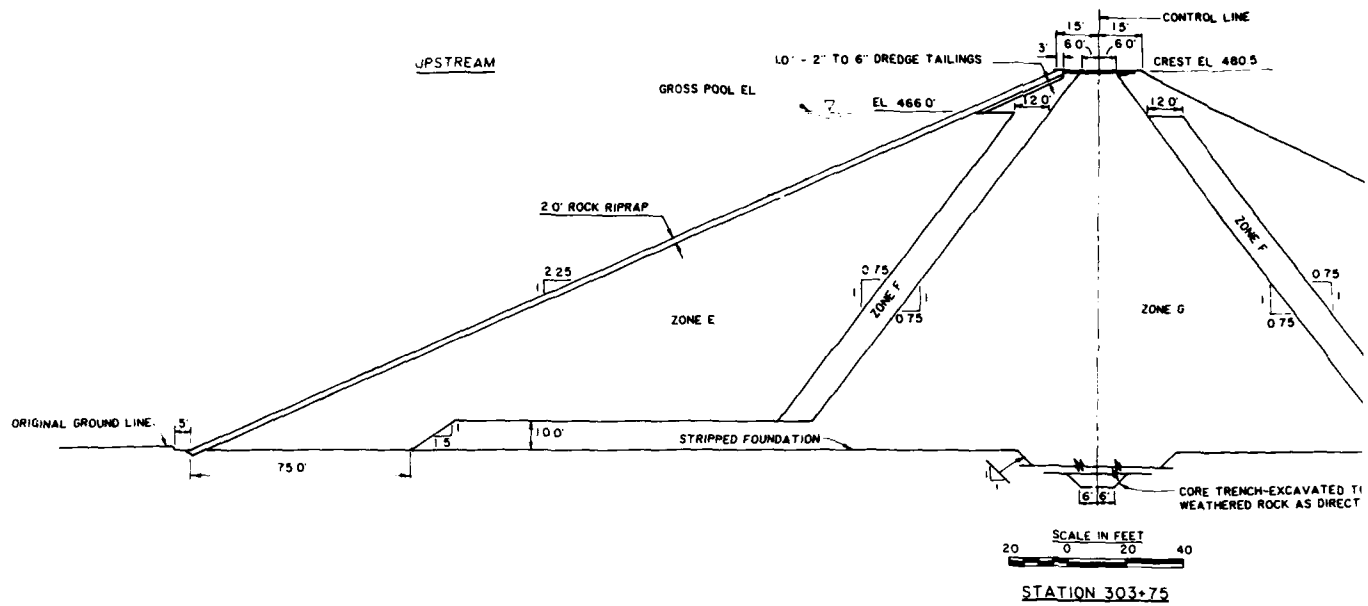
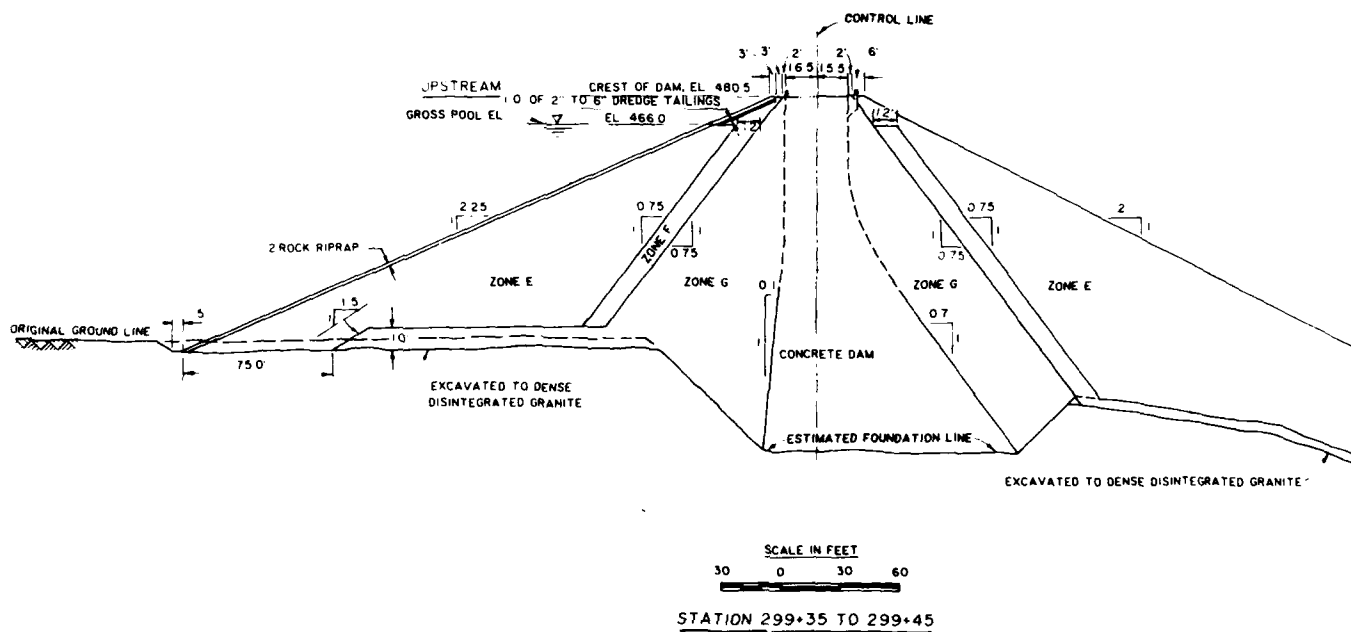
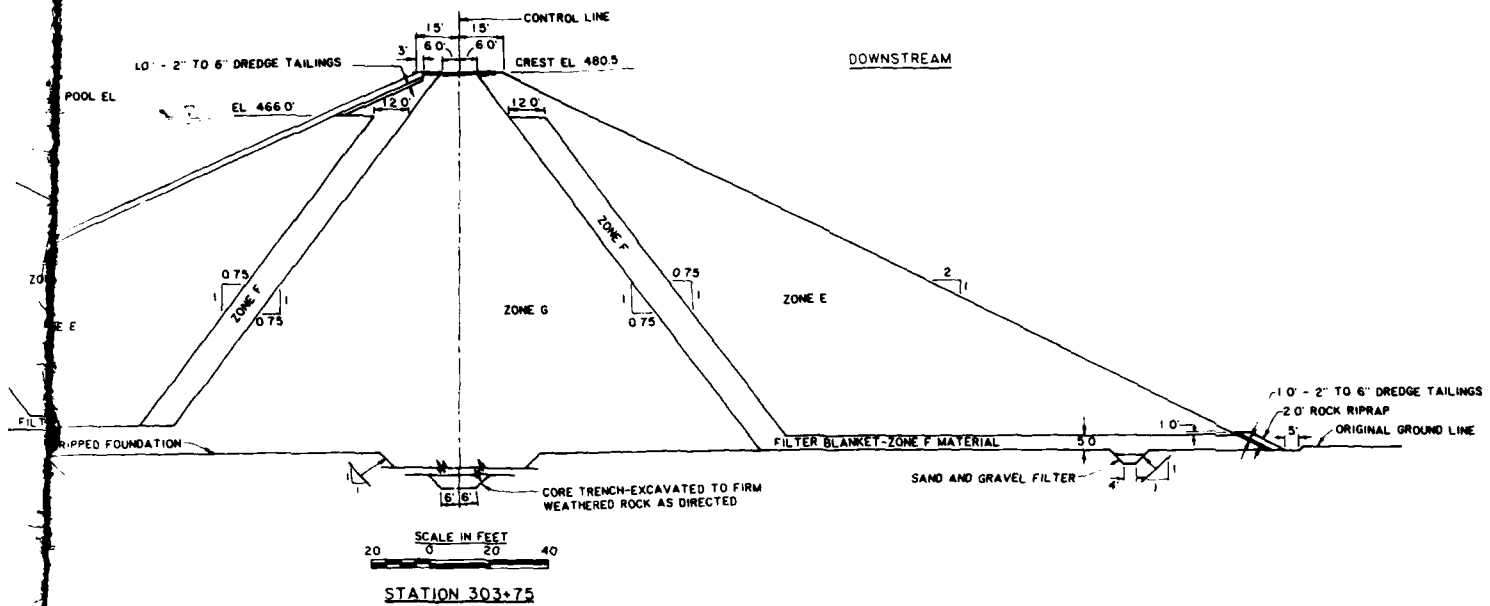
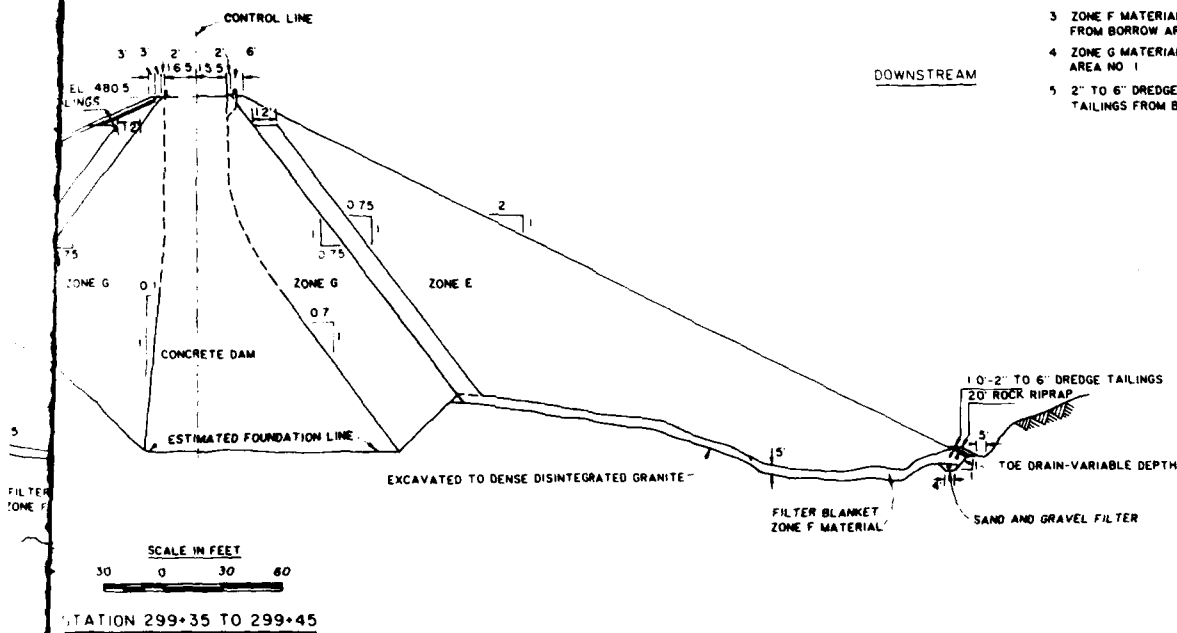
- NOTES
- 1 DATUM IS SEA LEVEL DATUM OF 1929.
  - 2 ZONE E MATERIAL TO BE UNPROCESSED COARSE DREDGE TAILINGS FROM BORROW AREA NO 5.
  - 3 ZONE F MATERIAL IS MINUS 2" COARSE DREDGE TAILINGS FROM BORROW AREA NO 5
  - 4 ZONE G MATERIAL IS DECOMPOSED GRANITE FROM BORROW AREA NO 1
  - 5 2" TO 6" DREDGE TAILINGS ARE PROCESSED COARSE DREDGE TAILINGS FROM BORROW AREA NO 5

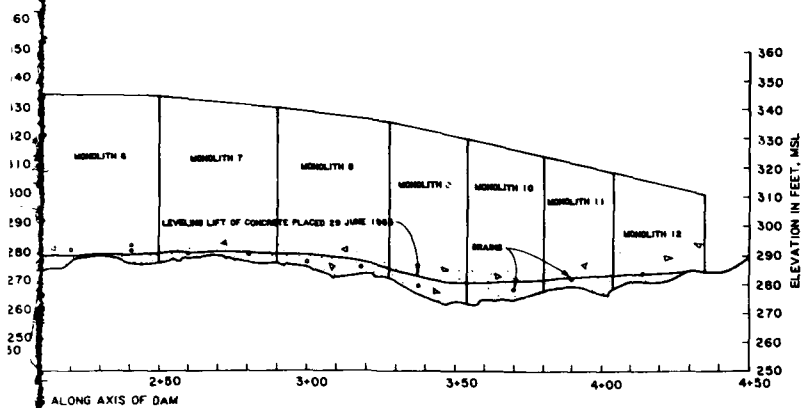
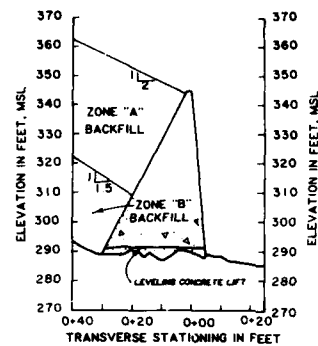
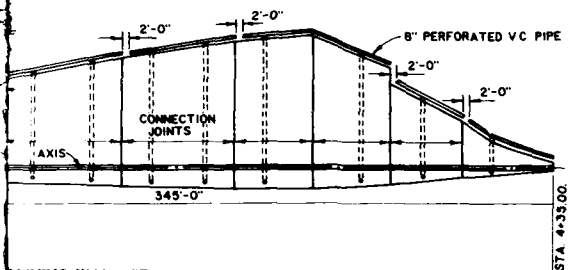
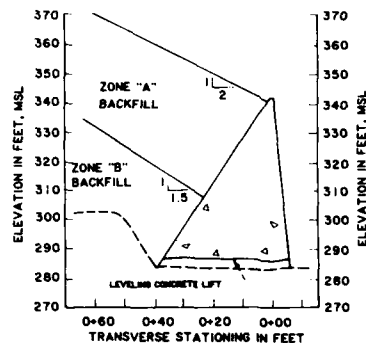
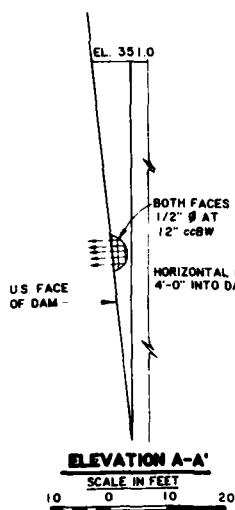
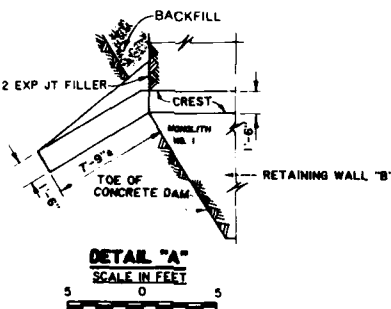
**Figure 14. Plan and sections of Retaining Wall B**

**ALONG AXIS OF RETAINING WALL "B"**

**TRANSVERSE CROSS-SECTION AT STATION 2+30**

**TRANSVERSE CROSS-SECTION AT STATION 1+90**

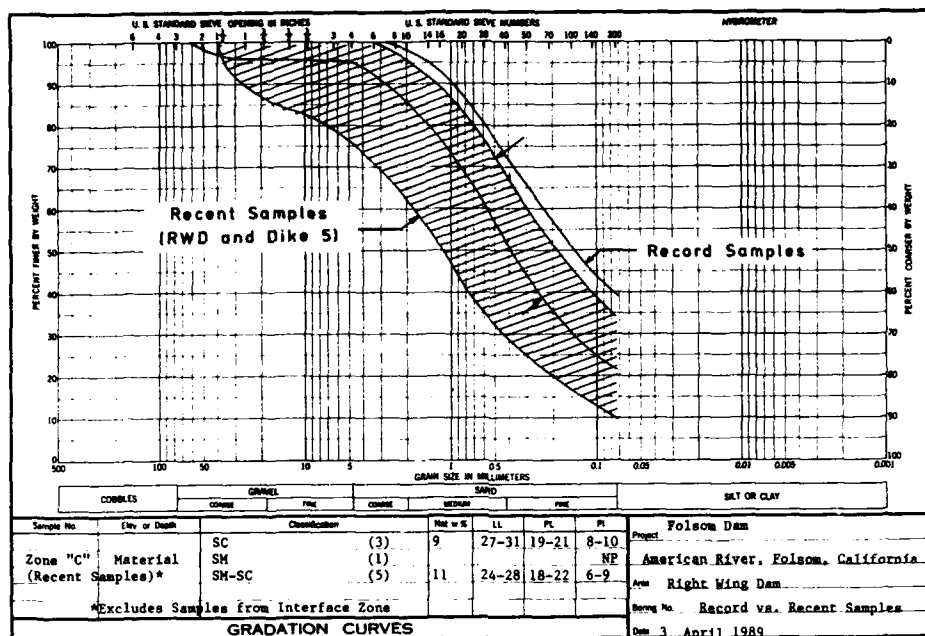
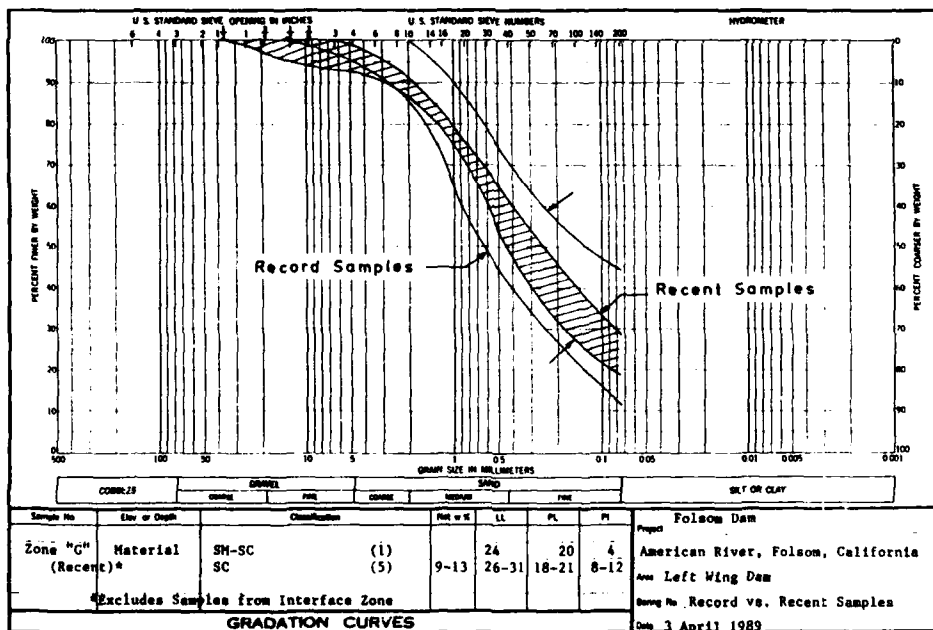
Figure 15. Grain size distribution for materials of Zone C in right Wing Dam and Zone G in Left Wing Dam

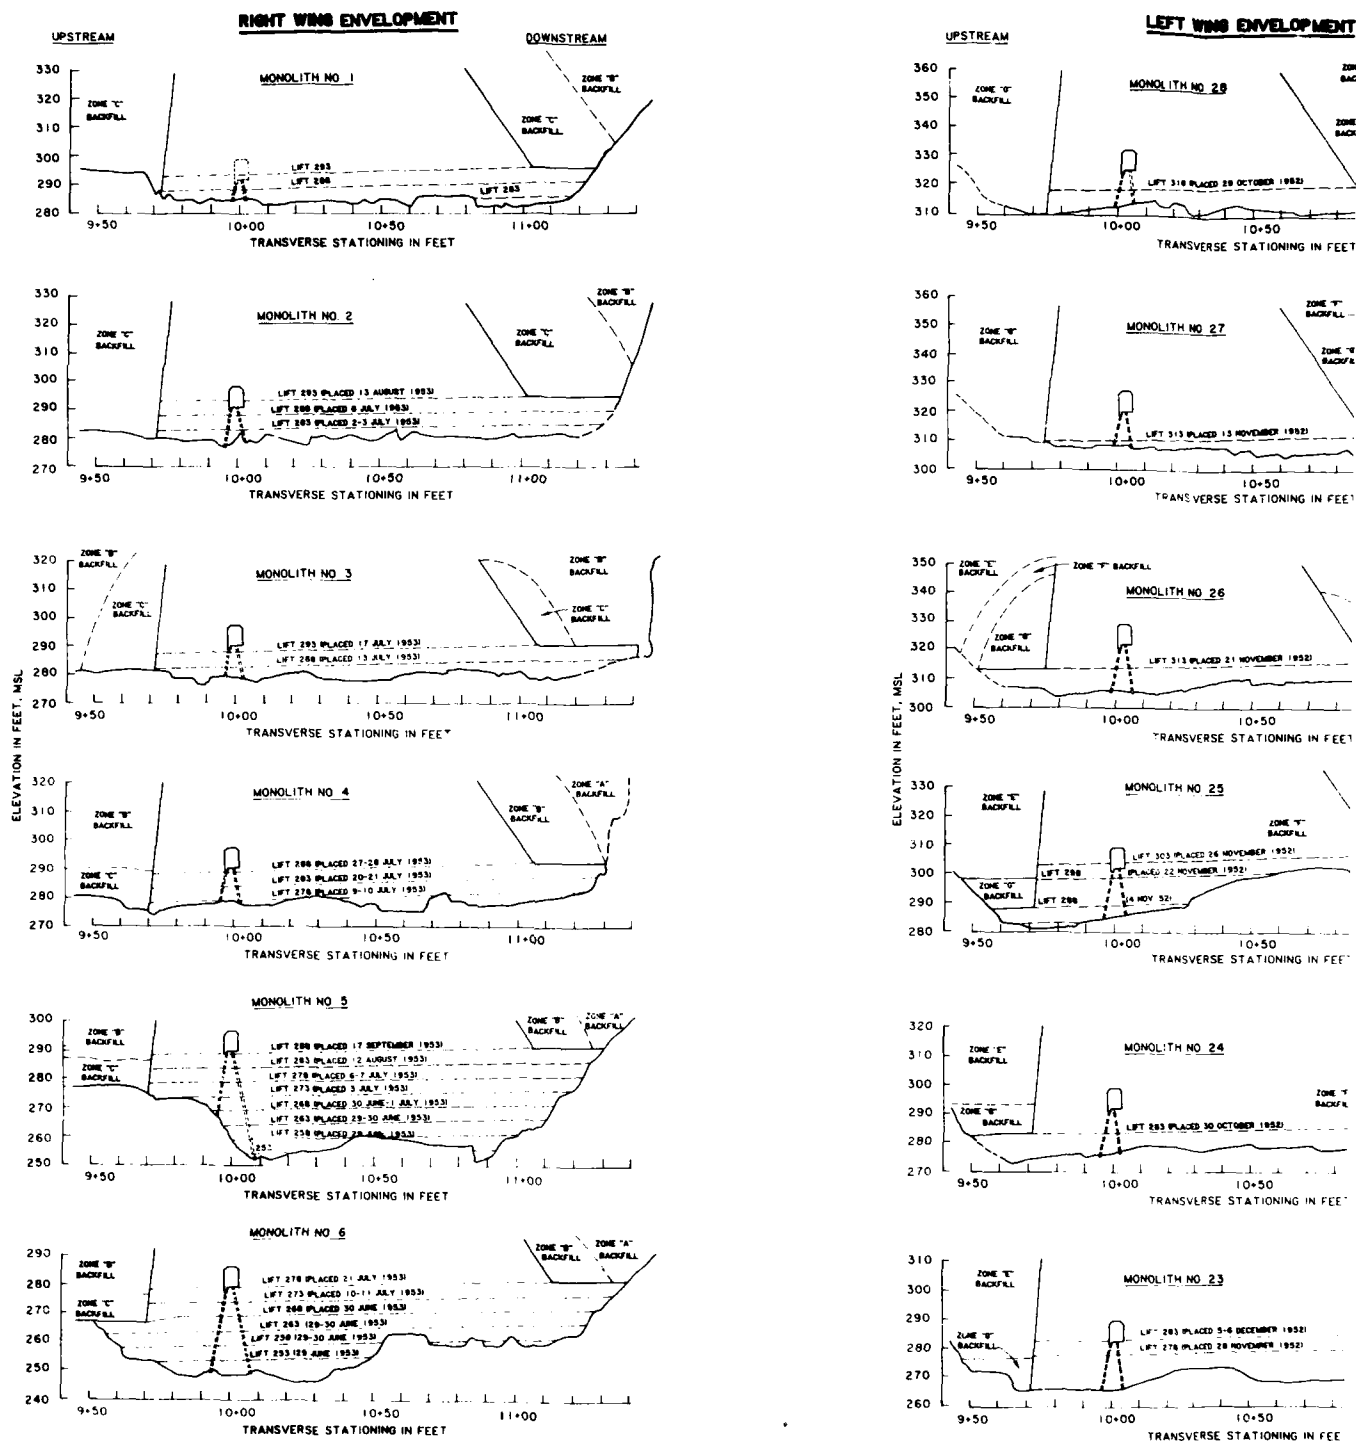
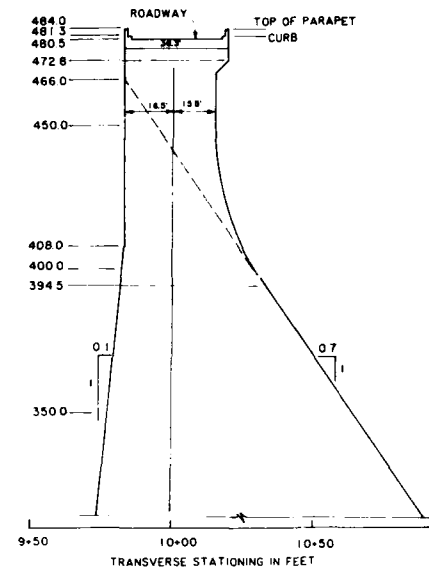
Figure 24. Transverse cross-sections of monoliths in int

- NOTES
- 1 CROSS-SECTIONS TAKEN FROM "FOUNDATION REPORTS" FOR MONOLITHS 1-2-3, 4-5-6, 22-23, 24-25, AND 26-27-28
  - 2 EXTENSIONS OF CROSS-SECTIONS DEVELOPED USING AM-1-9-396/5 2 AND SITE PHOTOGRAPHS. DASHED LINES INDICATE SOME QUESTION STILL EXISTS

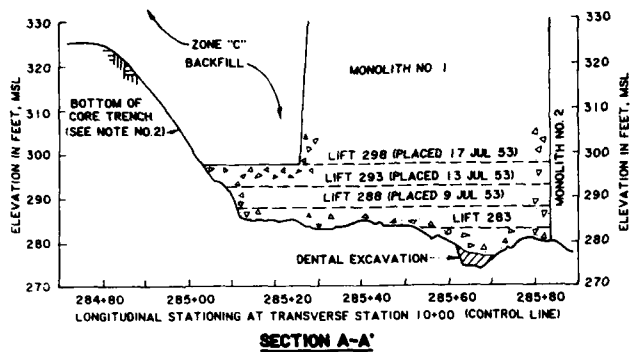
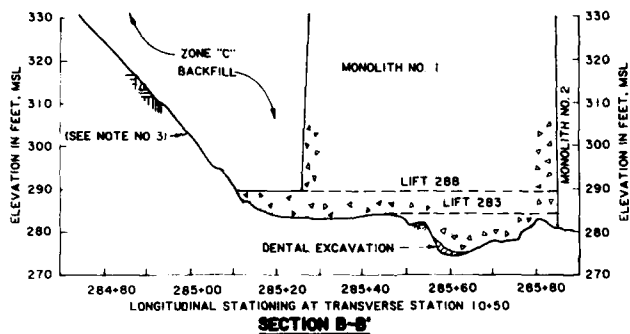
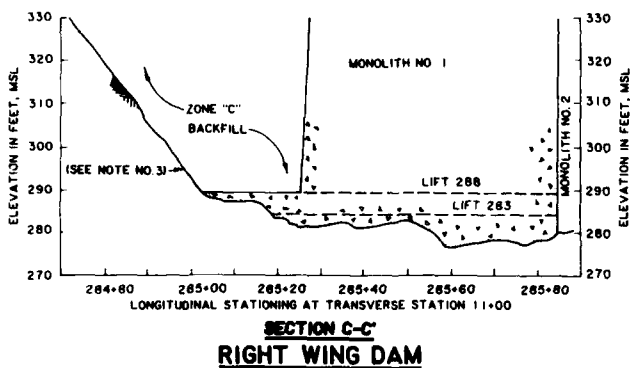
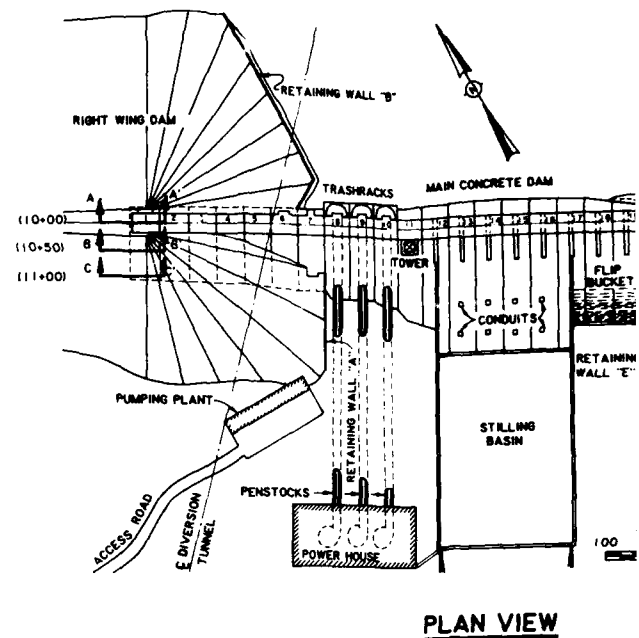
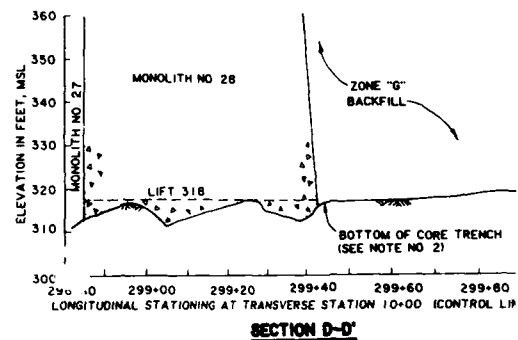
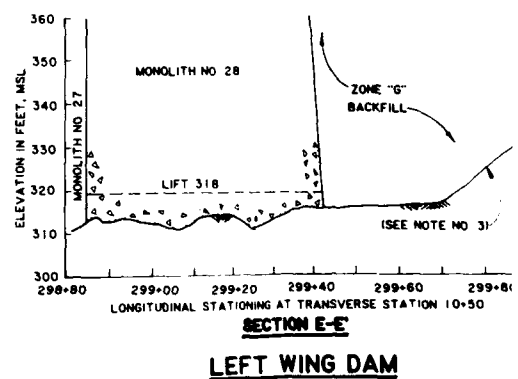
Figure 26. Longitudinal cross-sections of interface zone from end monoliths (Nos. 1 and 28)

57. Concrete extensions at two different elevations were constructed parallel to the dam axis at the right end of the CGD, Monolith No. 1, and are indicated in Figures 25 and 26. The photograph in Figure 25 shows the locations of these lateral extensions, as well as the downstream extension. These

58. The other lateral extension had a surface elevation of 288 ft (formed by lift 288); it extended from the centerline to the downstream foundation rock face, and tied into the downstream concrete extension which had a surface elevation of 293 ft (formed by lift 293). The downstream extension of Monolith No. 1 can be seen in Figure 25. The lateral extension at elevation 288 ft cannot be seen clearly in Figure 25 because of construction debris present in this area on the day the picture was taken. As discussed in the next section, this debris was cleared prior to placement of fill in this area. The design of this area did not call for the construction of concrete extensions on the upstream side of the envelopment monoliths, except at Monolith No. 6, as shown in Figure 24.

59. At the left end of the CGD, Monolith No. 28, lateral concrete extensions were not constructed. It can be seen in the photograph of the foundation preparation for Monolith No. 28, Figure 22, and the longitudinal sections in Figure 26, that a fairly wide, relatively flat rock foundation surface existed in this area upon which the embankment fill could be compacted for a positive contact between soil, concrete and foundation rock. Downstream concrete extensions were constructed at the bases of Monolith Nos. 24 through 27, as shown in Figure 24. (These extensions can be seen in the background of the photograph in Figure 30.) The foundation rock in this area sloped steeply towards the river channel, and also formed a fairly steep, blocky slope face downstream (see photographs in Figures 19 through 23). These downstream concrete extensions (shown in Figure 22) were sufficiently long to provide a large, flat surface upon which the Zone G core, Zone F gravel filter, and Zone E gravel shell materials could be compacted. Figure 24 shows that concrete extensions were constructed upstream for Monolith Nos. 24 through 26.

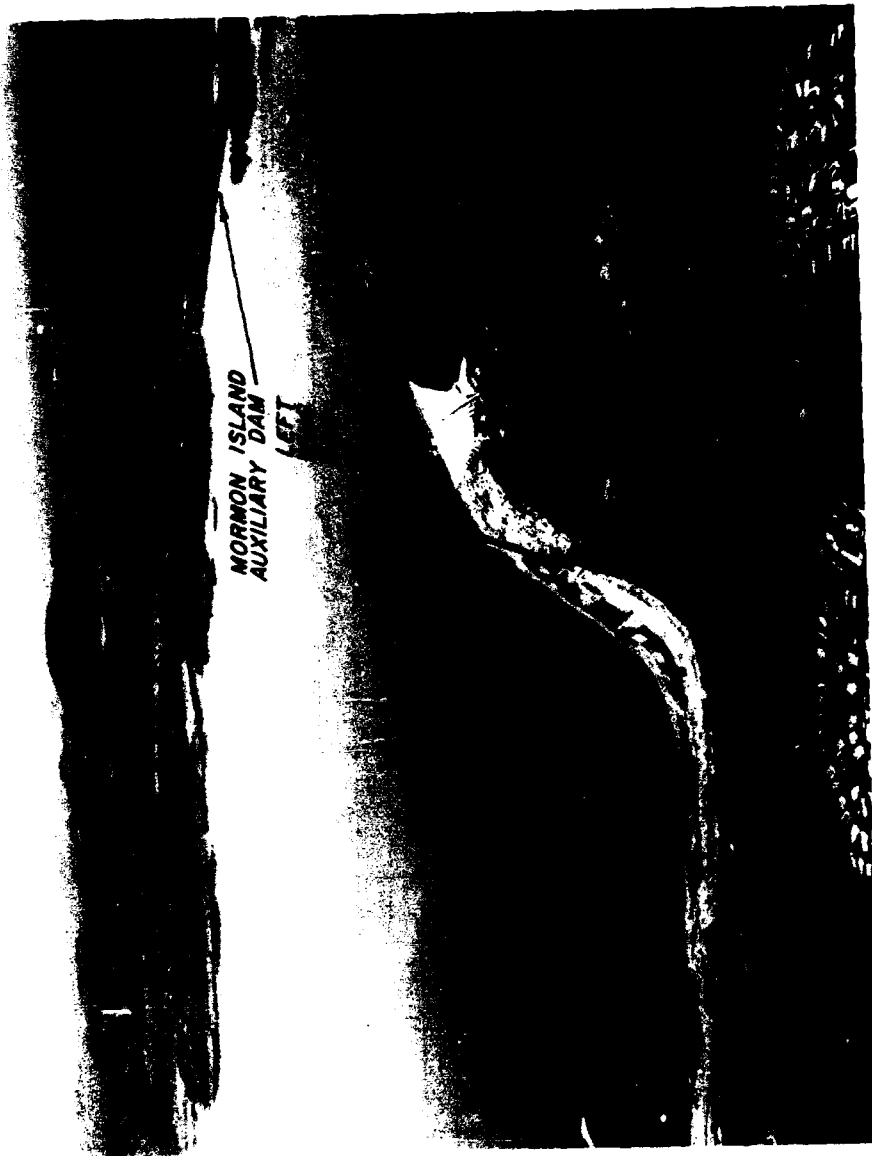
Figure 41. Downstream portion of Folsom Dam and Reservoir following initial filling of reservoir (looking east)

82. Figure 39 is a photograph dated 8 September 1954 that shows that the railway located on the downstream side of the left abutment still inhibited placement of downstream gravel shell material at the LWD. The impact is more pronounced in the photograph shown in Figure 40. A view of the completed dam following initial reservoir filling is provided in the photograph shown in Figure 41.

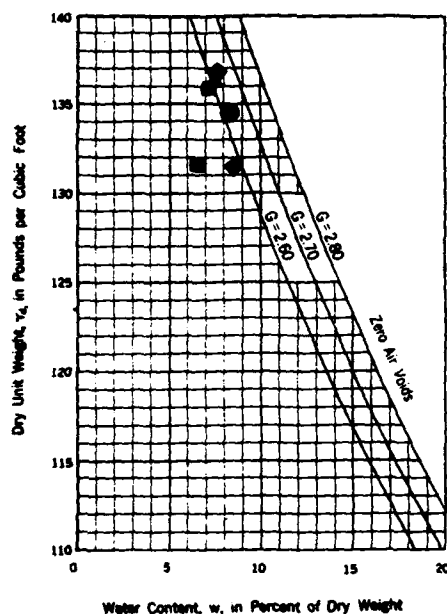
Modified compaction test (AASHTO T99-49)

Figure 45. Ranges in results of moisture-density relationships at LWD interface zones

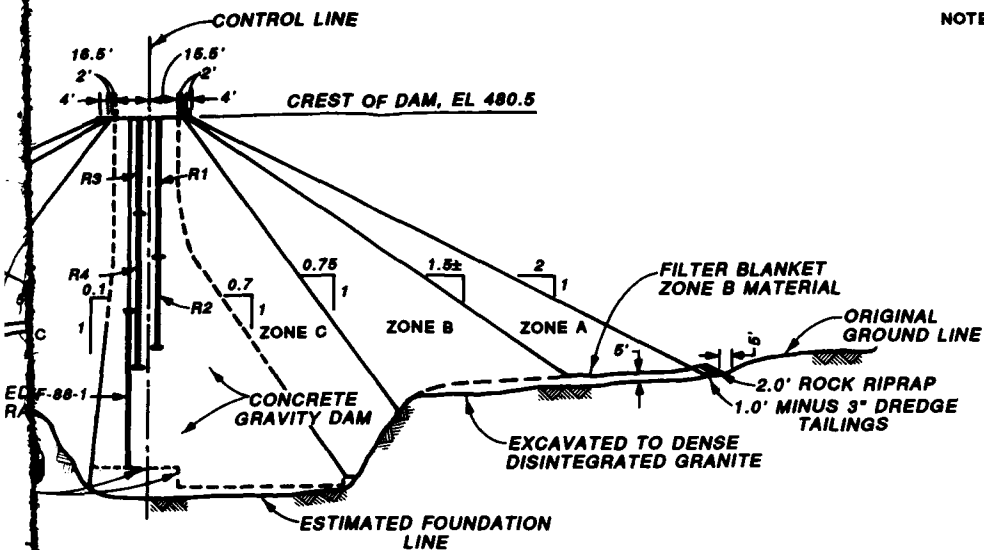
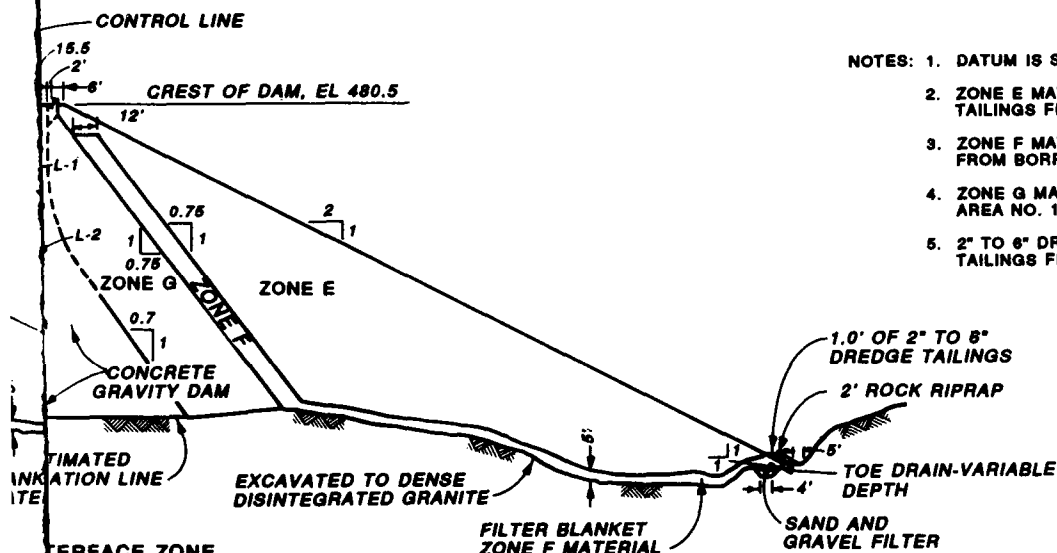
Figure 46. Cross sections of RWD and LWD

**INTERFACE ZONE**  
285+25 TO 285+35

**INTERFACE ZONE**  
299+35 TO 299+45

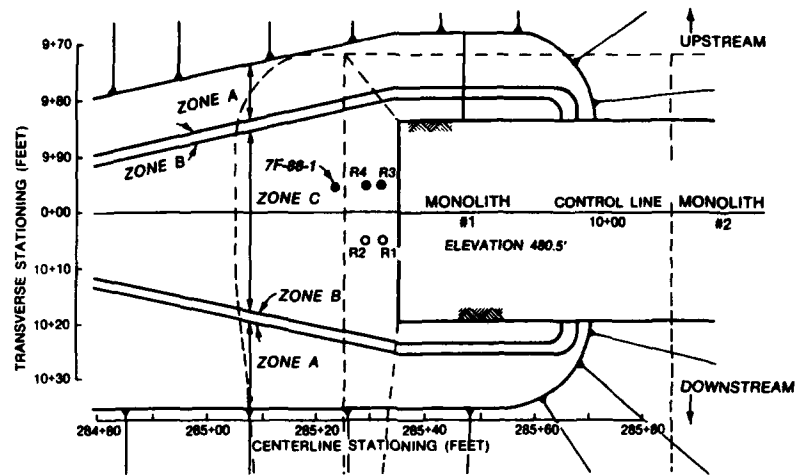
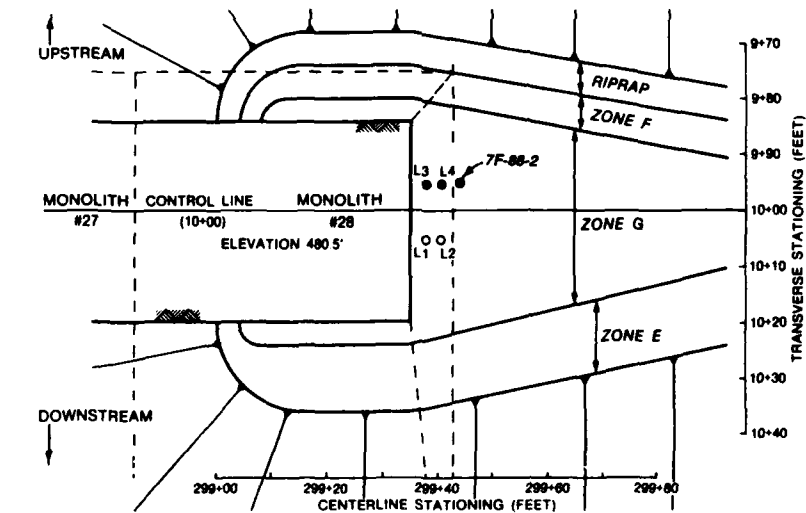
# RIGHT WING DAM INTERFACE

# LEFT WING DAM INTERFACE

Figure 47. Plan view of interface zones at ends of the CGD showing locations of drill holes

100. It was necessary to derive an energy efficiency ratio that would be appropriate for SPT N-values measured with the safety hammer regulated by wireline (borings 7F-88-1 and 7F-88-2 shown in Figure 47). This means of releasing the hammer is not discussed by Seed et al. (1985) who suggest energy efficiencies for different types of systems. The energy efficiency was estimated from a comparison of  $N_1$  values derived from the wireline and safety hammer system with  $(N_1)_{60}$  derived from the rope-and-cathead and safety hammer system at equal depths. At each interface zone, there is some overlap in the depths of SPT sampling using the two systems. At the RWD, SPT measurements were made in borings R-4 and 7F-88-1 in the 30-ft interval between elevations 380.5 and 350.5. At the LWD, SPT measurements were made in borings L-4 and 7F-88-2 in the 11-ft interval between elevations 380.5 and 369.0. The holes at each end are separated by about 7 ft which minimizes the potential effect of material variability.

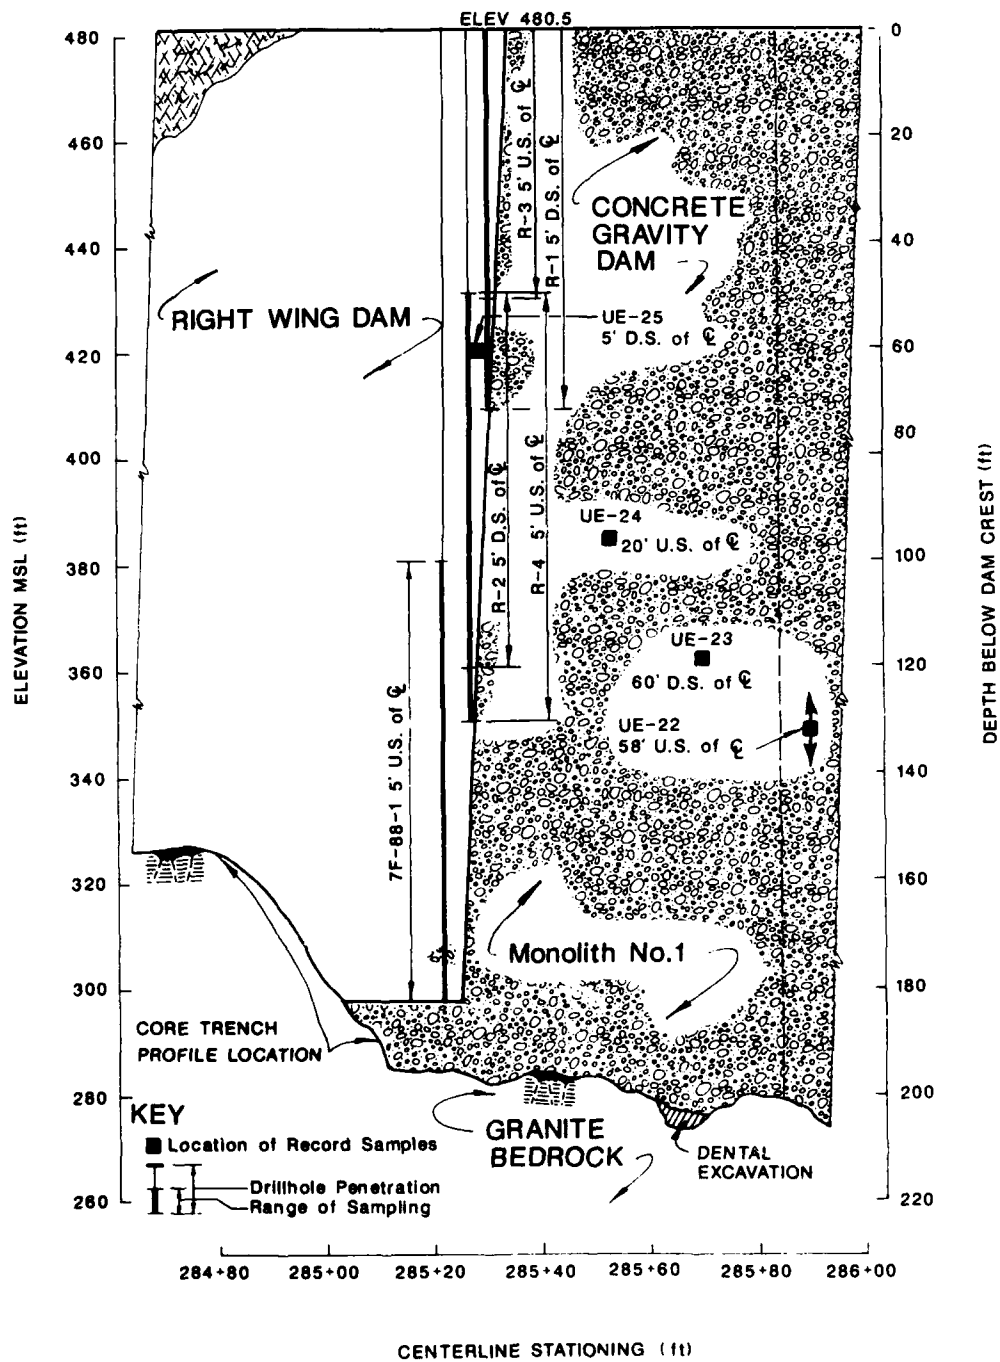
Figure 48. Profile along centerline at interface between RWD and CGD showing depths penetrated by drill holes and sample locations

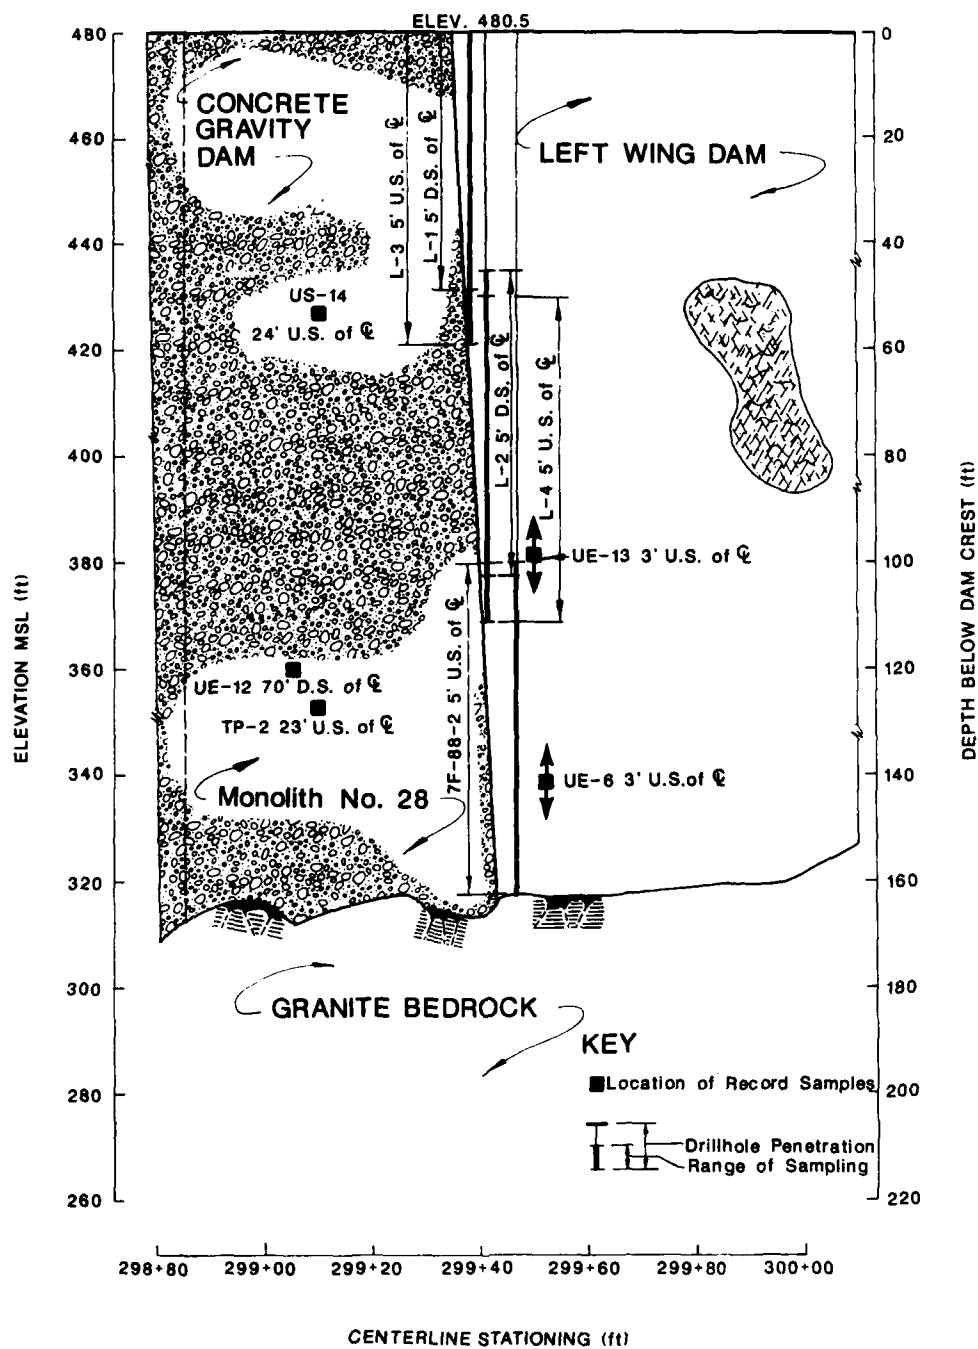
Figure 49. Profile along centerline at interface between LWD and CGD showing depths penetrated by drill holes and sample locations
